# Prince George's County, MD Polychlorinated Biphenyls (PCBs) Total Maximum Daily Load (TMDL) Stormwater Wasteload Allocation (SW-WLA) Watershed Implementation Plan

February 20, 2024  
(Revised November 6, 2024)

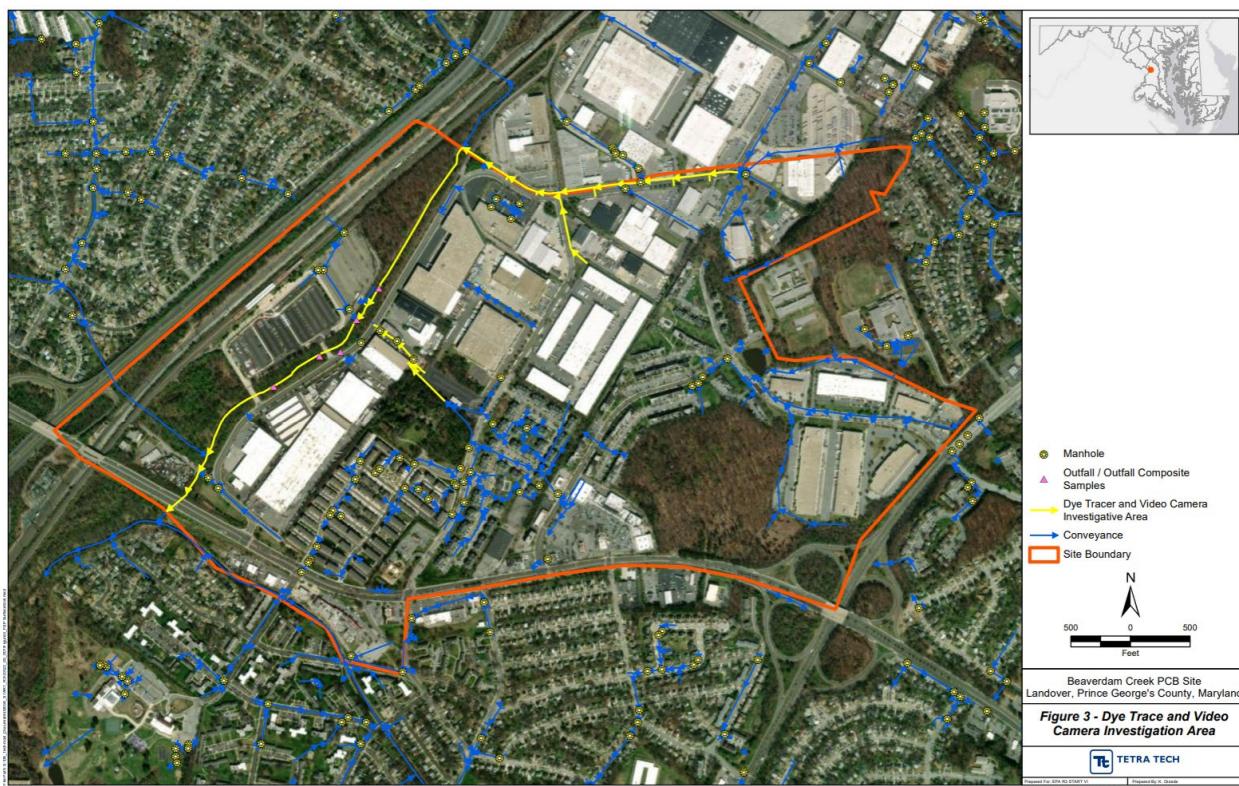
Figure 23. Dye Trace and Video Study in the Lower Beaverdam Creek Watershed.

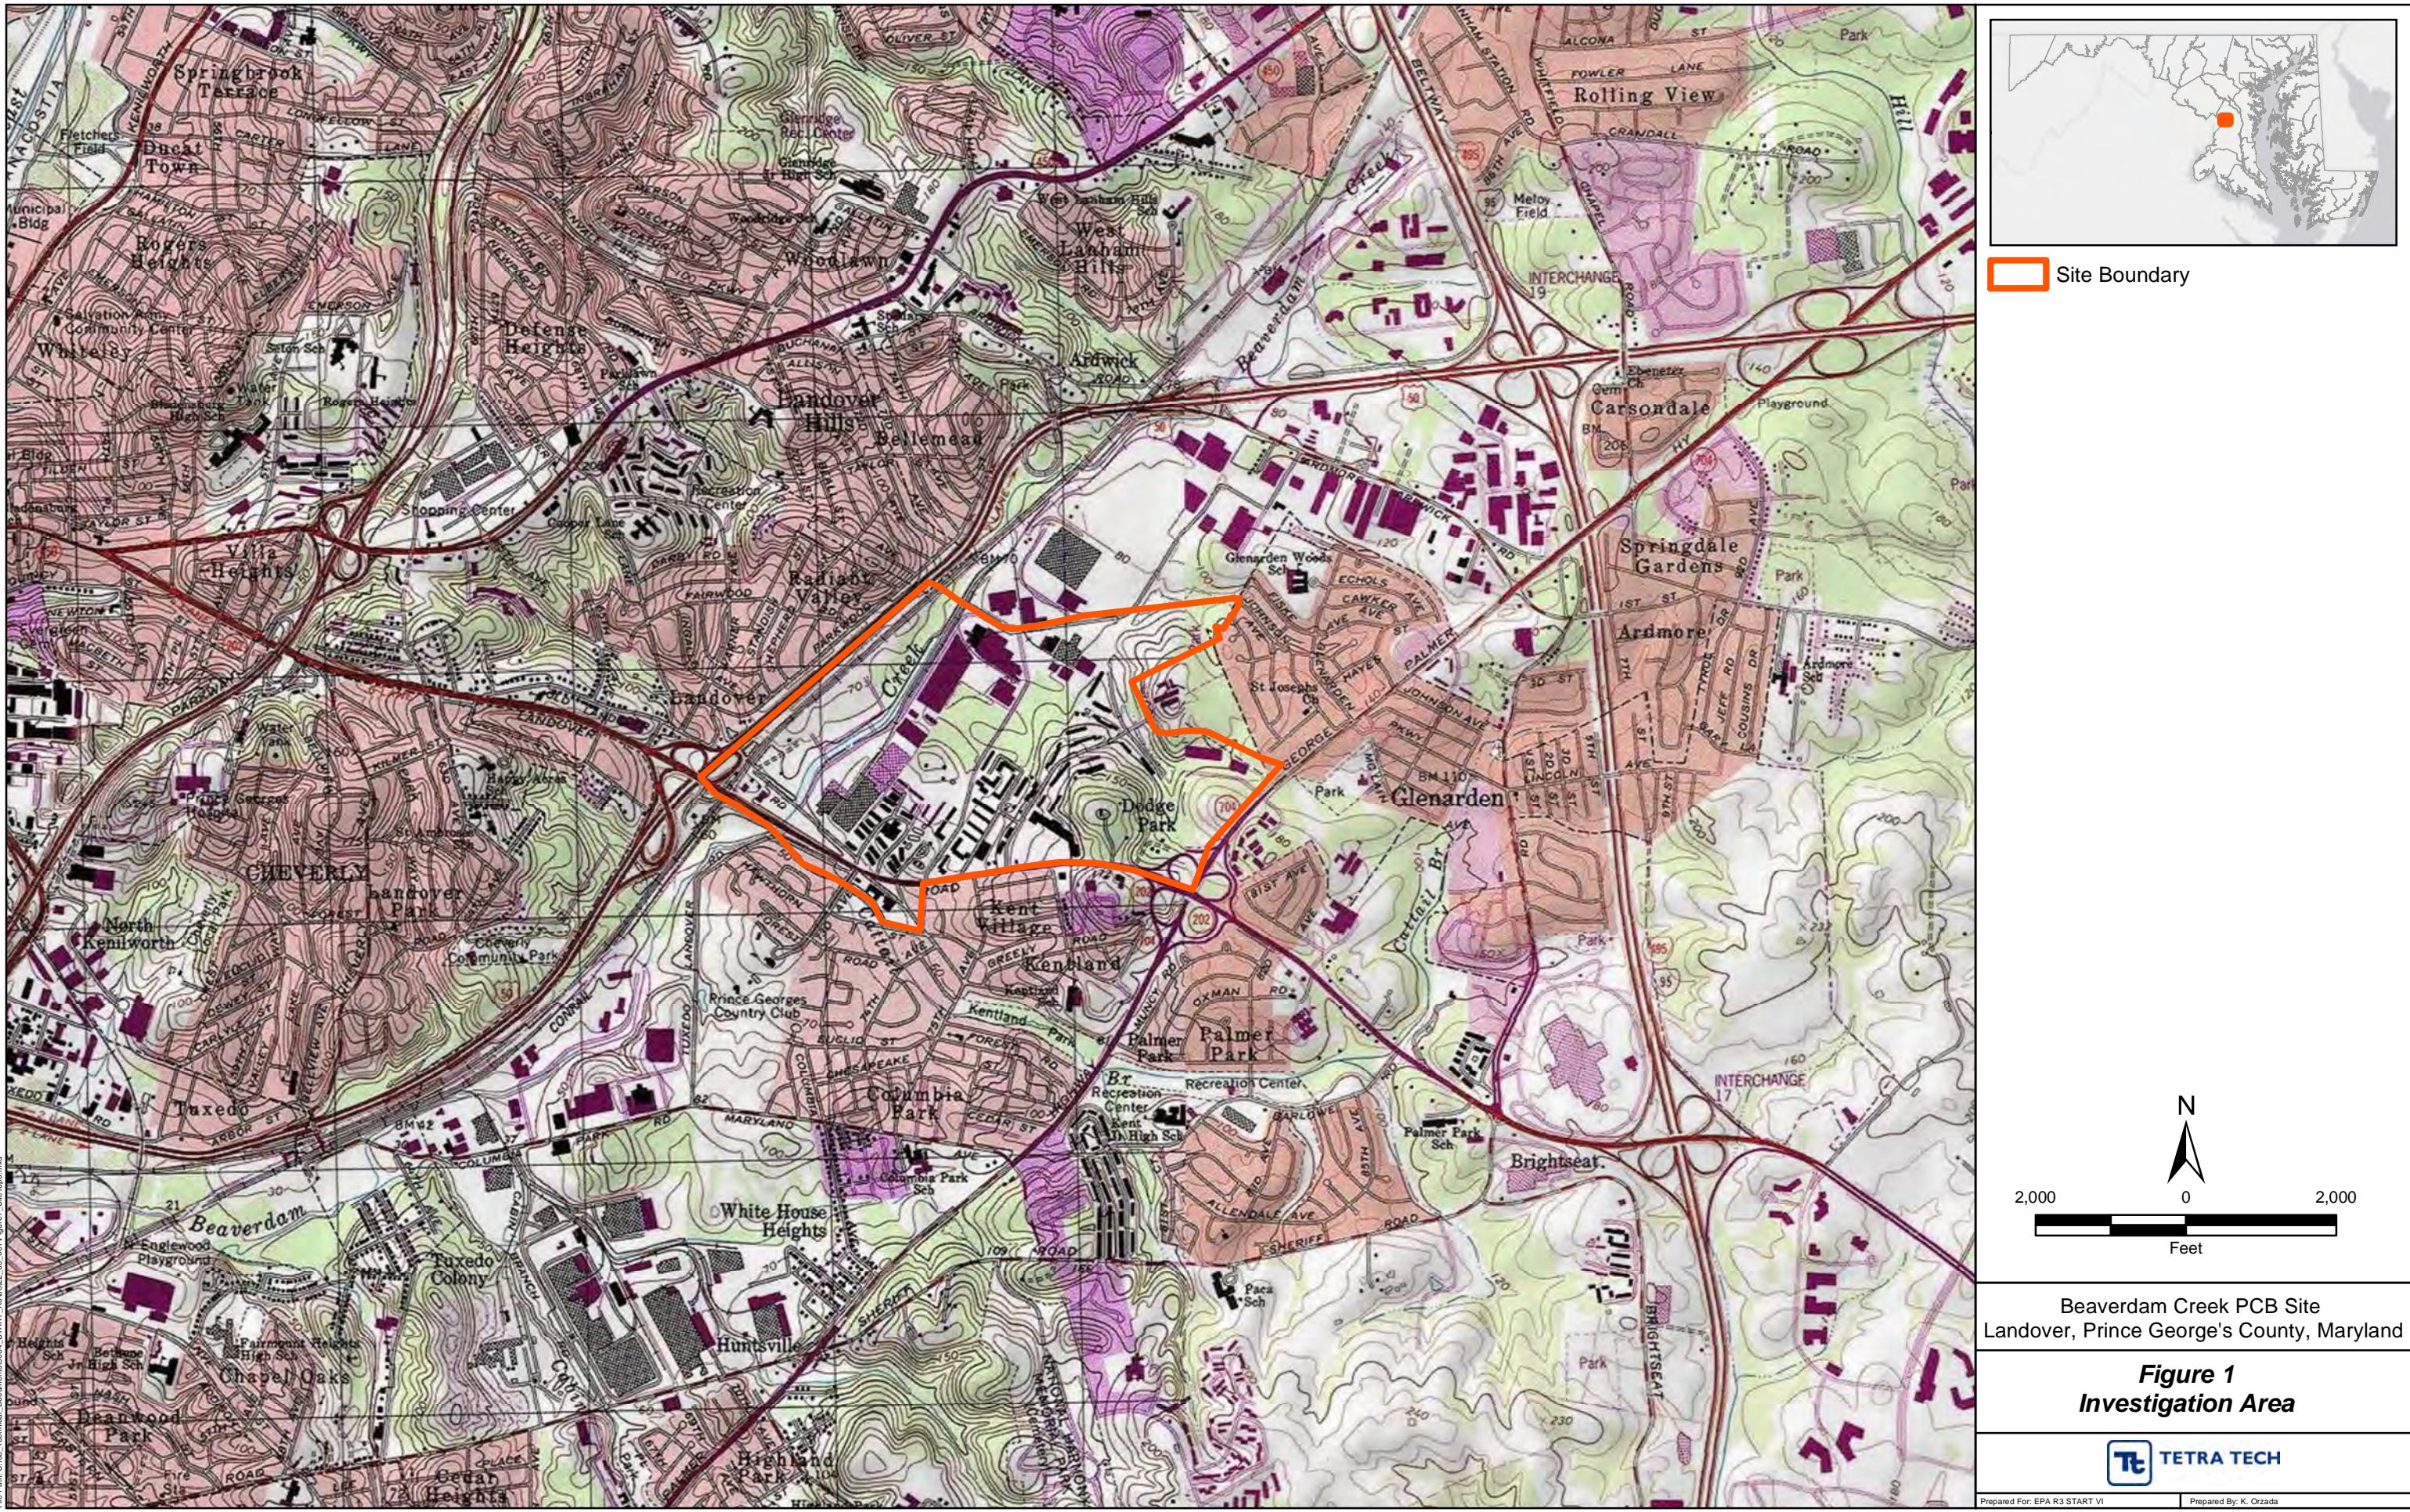
The extent of the Beaverdam Creek PCB Site is unknown. It is adjacent to Beaverdam Creek in Landover, Prince George's County, Maryland at 38.93256 degrees latitude and -76.88814 degrees longitude as measured from the center of the study area (Figure 1). EPA and Tetra Tech conducted research to identify potential sources of PCB contamination to Beaverdam Creek, with a focus on the Pennsy Drive area, by reviewing Beaverdam Creek PCB contamination investigative reports, aerial photographs, database searches, city directories, storm drain and sewer maps, and other resources, as well as conducting two site reconnaissance's. The research identified the locations where the dye tracing and video survey should be conducted. A report summarizing the research will be submitted to EPA under separate cover.

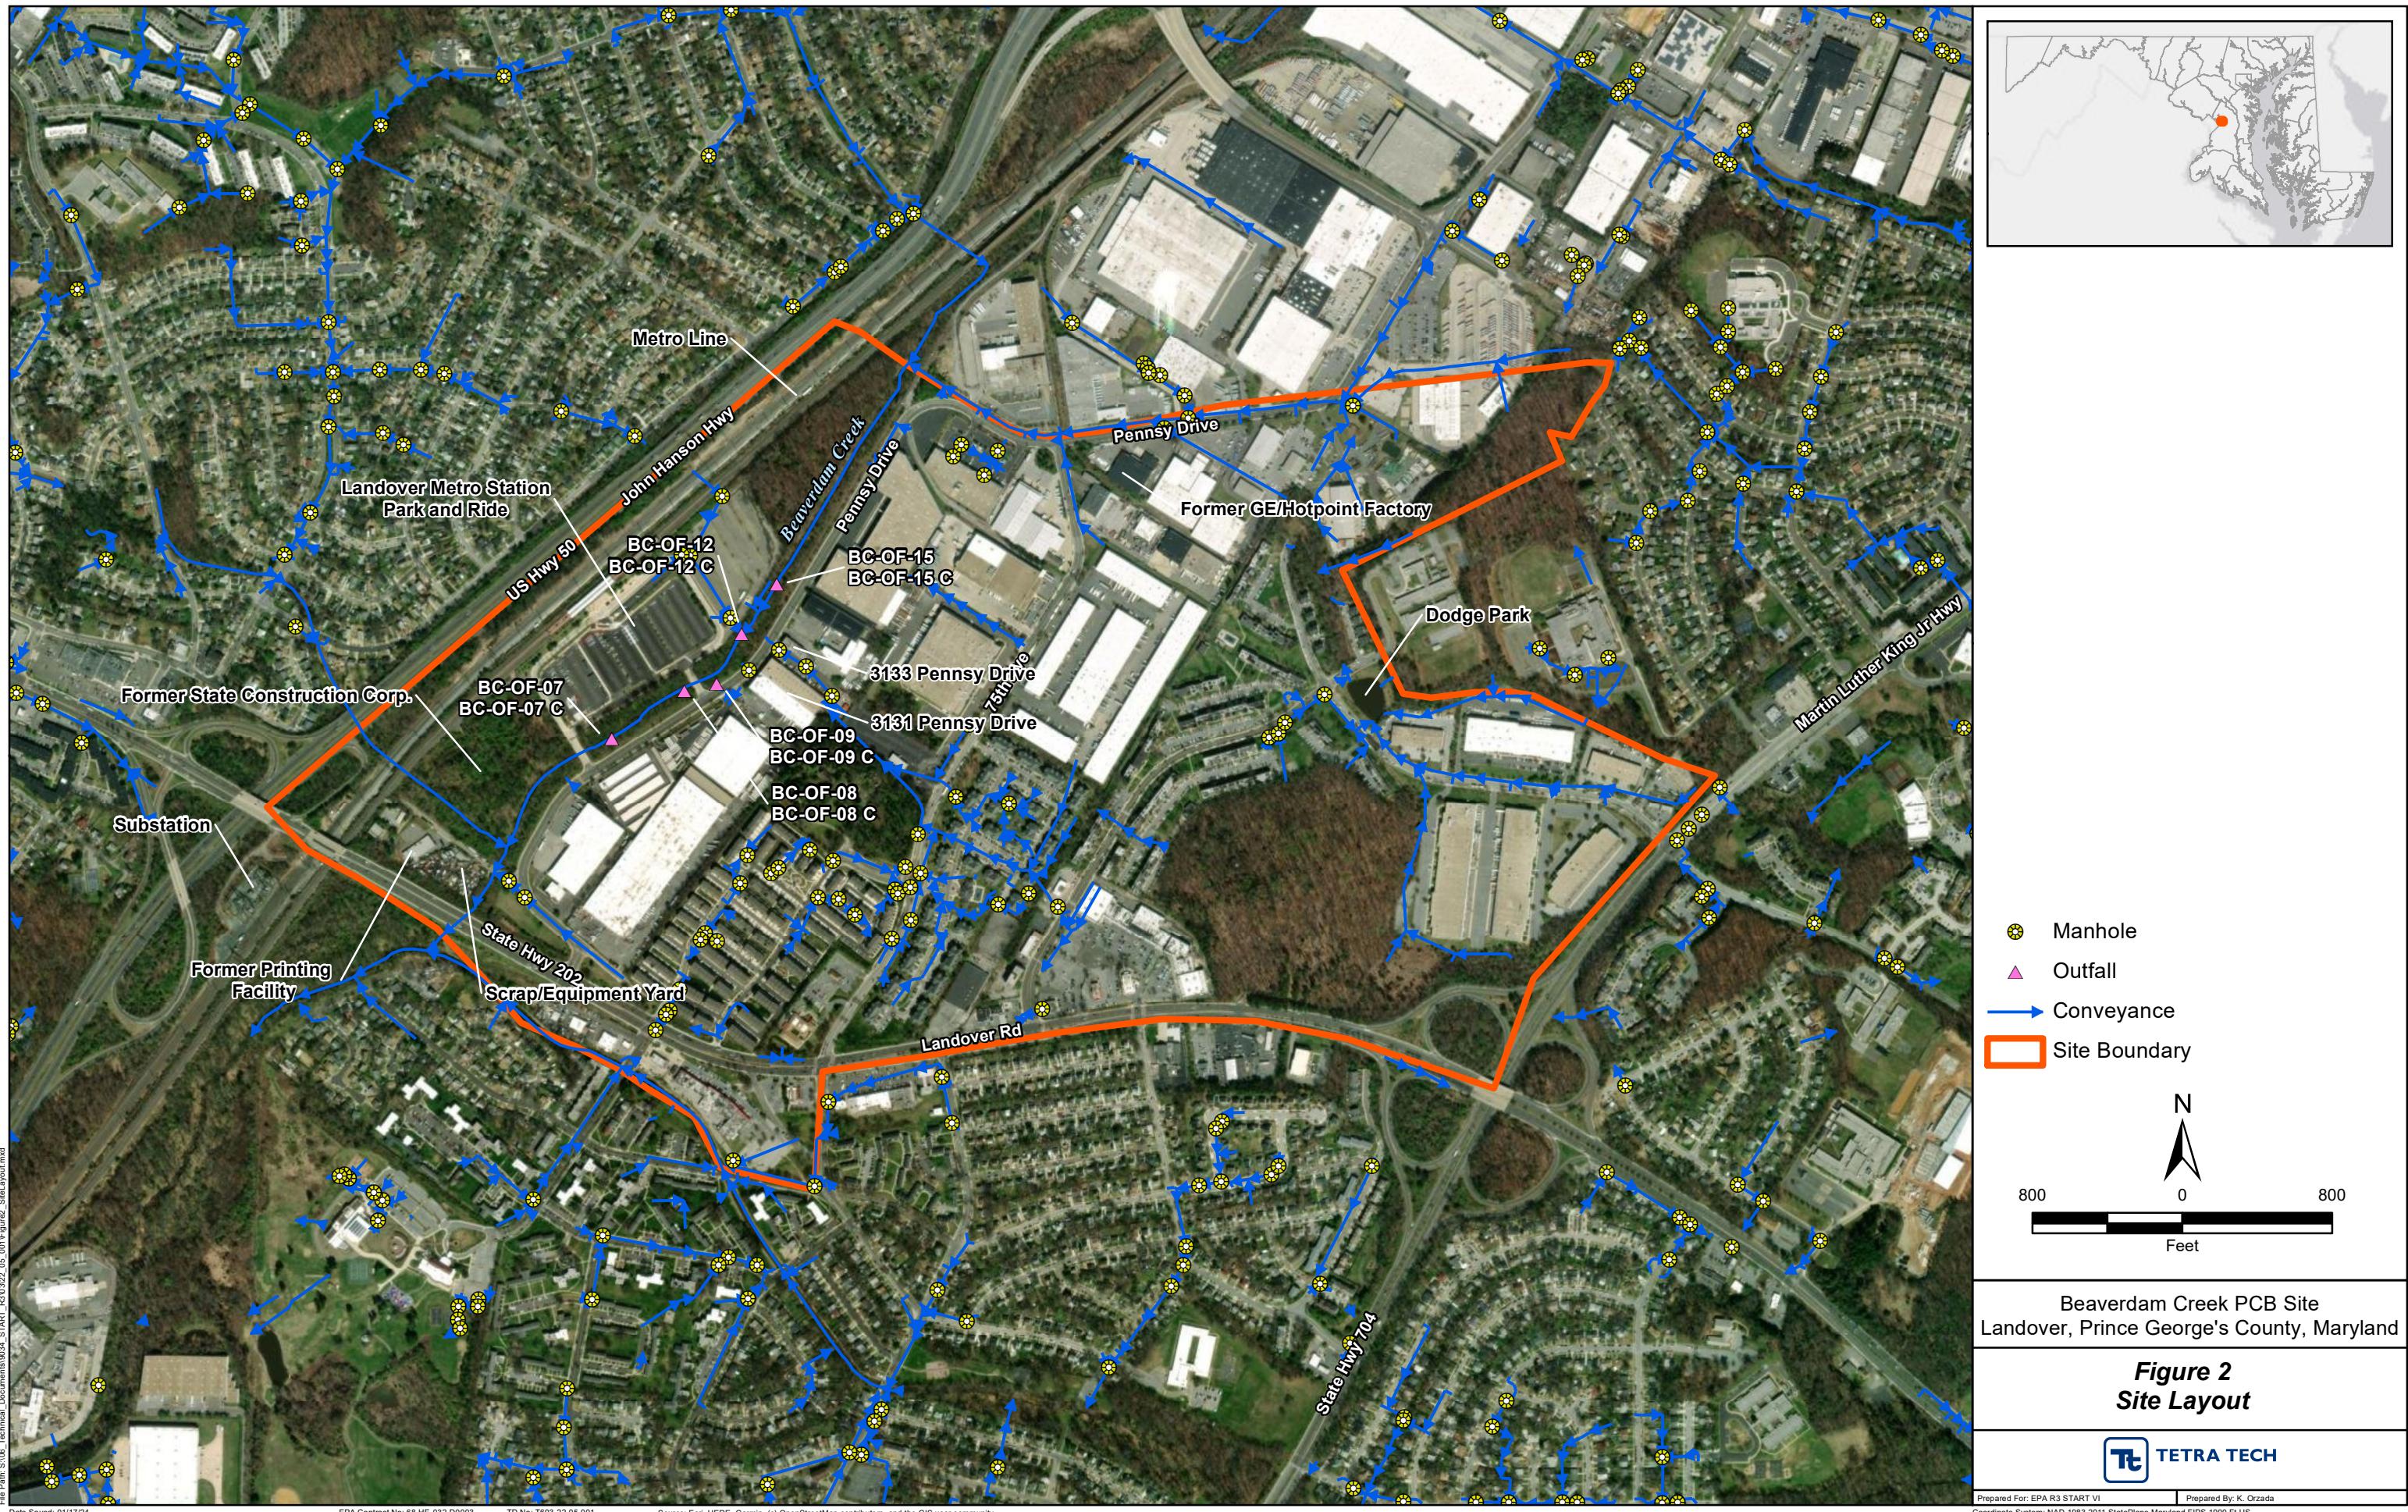
The study area includes areas that drain to Beaverdam Creek and may have contributed to the PCB contamination in the creek as well as those that drain to the MS4 storm sewer system and associated outfalls as shown in Figure 2. The study area is bound to the northwest by US Highway 50, Metrorail railroad tracks, Washington Metrorail Landover Station and Landover Metro Station Park and Ride; to the northeast by the MS4 conveyance system and Pennsy Drive; to the east by State Highway 704; and to the south by State Highway 202. Beaverdam Creek and Pennsy Drive are parallel to each other, and, within the study area, Beaverdam Creek flows from the northeast to the southwest along the northwest side of Pennsy Drive

(Figures 1 and 2). Land use in the study area is primarily commercial with mixed multifamily units, a childcare center, and Dodge Park.

Investigations described in Section 3.3 of this plan identified areas of known and suspected sources of PCB contamination to Beaverdam Creek, which therefore are part of the study area. PCBs are known to be associated with the Pennsy Drive area, which is comprised of Jack Stone Sign Company, and Jack Stone Electric Sites. Other possible sources of PCB contamination include Former GE/Hotpoint Factory, Former State Construction Corporation, Former Printing Facility, Scrap/Equipment Yard, Electrical Substation, and the Metro line (Figure 2).

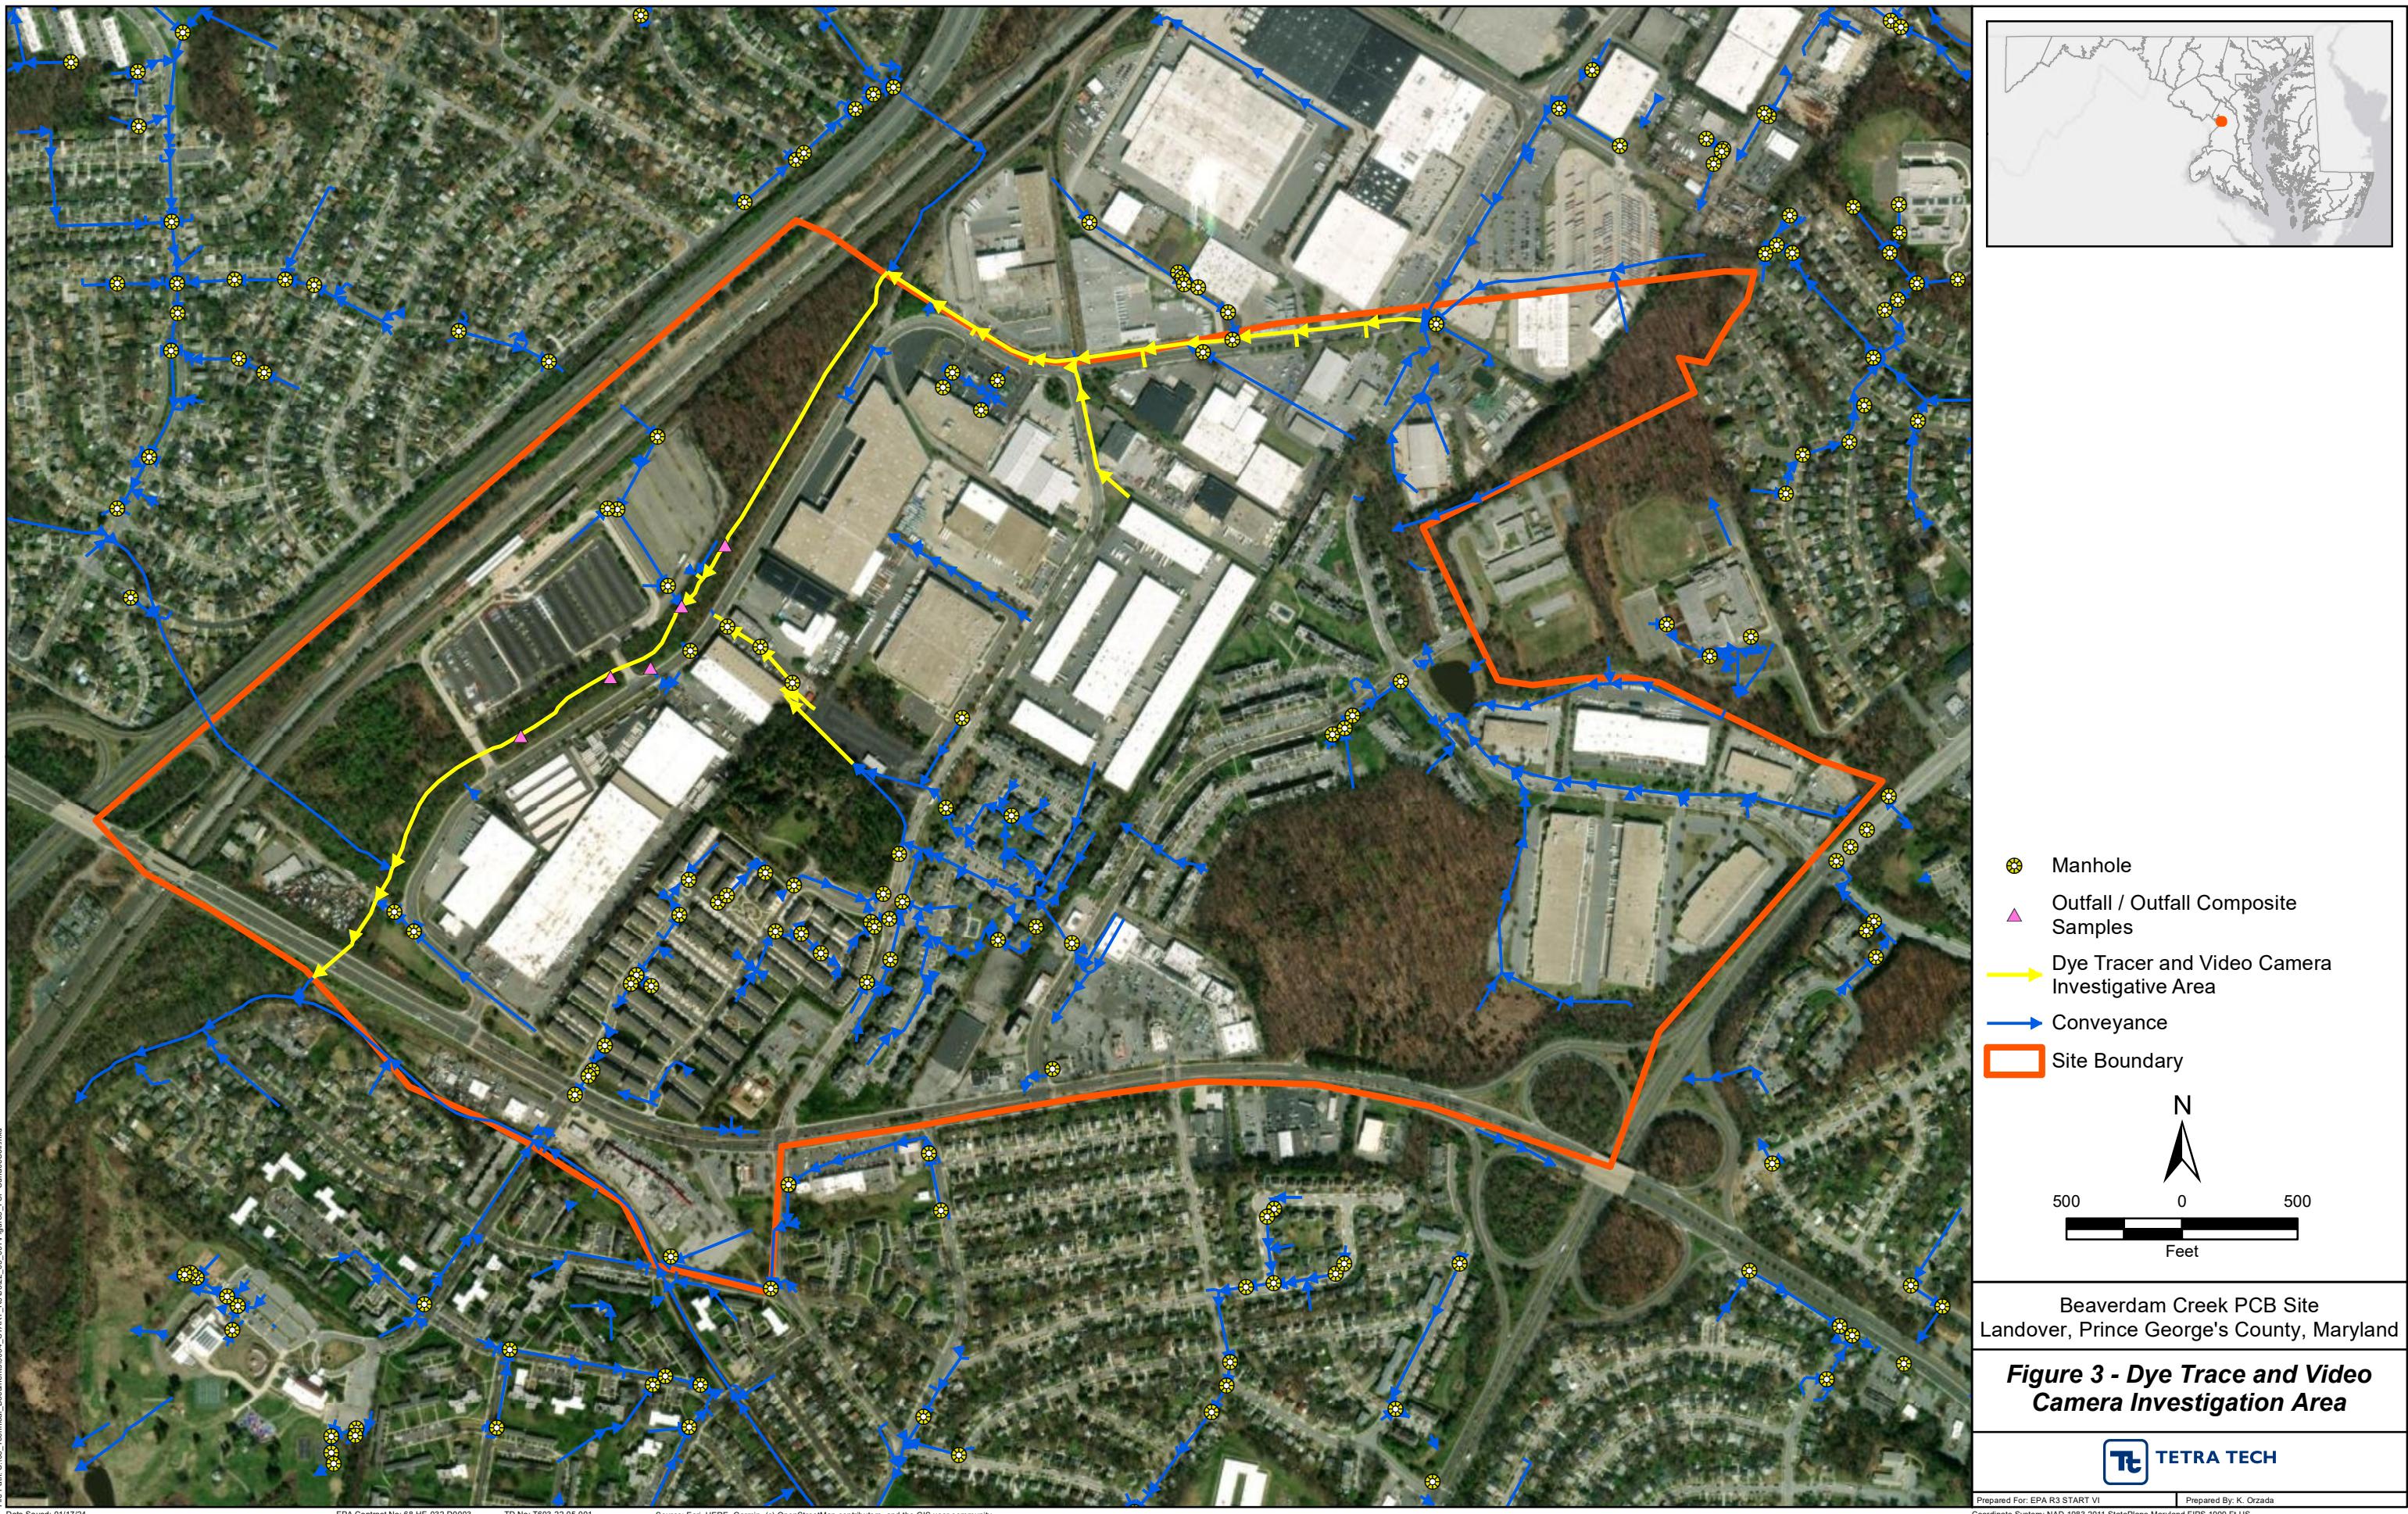
A comprehensive video survey will be performed by a subcontractor of the MS4 stormwater system associated with the outfalls of interest, OF-07, OF-08, OF-09, OF-12, and OF-15, and, potentially, other locations of interest (Figure 2). Figure 3 shows the location of the dye tracer and video camera investigative

area which includes Old Landover Road and Pennsy Drive near that Road which extends up to the GE Hotpoint property. Data obtained as part of the video survey as well as the dye tracer data will be used to prepare a map of the stormwater lines and will be compared to maps of the MS4 system provided by MDE and illustrated in Figure 2. The equipment used to perform the video survey will be capable of proceeding over or through areas with small buildups of sediment and debris, if encountered. The video survey will

*Illicit Discharge Detection and Elimination, A Guidance Manual for Program Development and Technical Assessments*, which is published by the Center of Watershed Protection and funded wholly or in part by the EPA, states that the test should start by introducing the dye into the manhole closest to the discharge of interest and moving from the most downstream or downflow manhole upward. Specially, “Crews can work progressively up the trunk from the outfall and test manholes along the way (Center for Watershed Protection 2004).” In consultation with the subcontractor, Tetra Tech will follow this procedure. Dye will be poured into the most downstream manhole of each outfall of interest and may also be poured into storm drain inlets into which surface stormwater runoff from potential PCB contamination sources drains into the MS4 stormwater system. Monitoring will be performed to determine/verify the probable point(s) of entry (PPE) into Beaverdam Creek. This information will be used to identify potential additional stormwater and sediment sampling locations at manholes in the MS4 system, upstream of the outfall for Phase II (Figure 3). Note that dye tracing is not effective in finding indirect discharges to the storm drain network.
